# Timber sash windows

ENGLISH HERITAGE

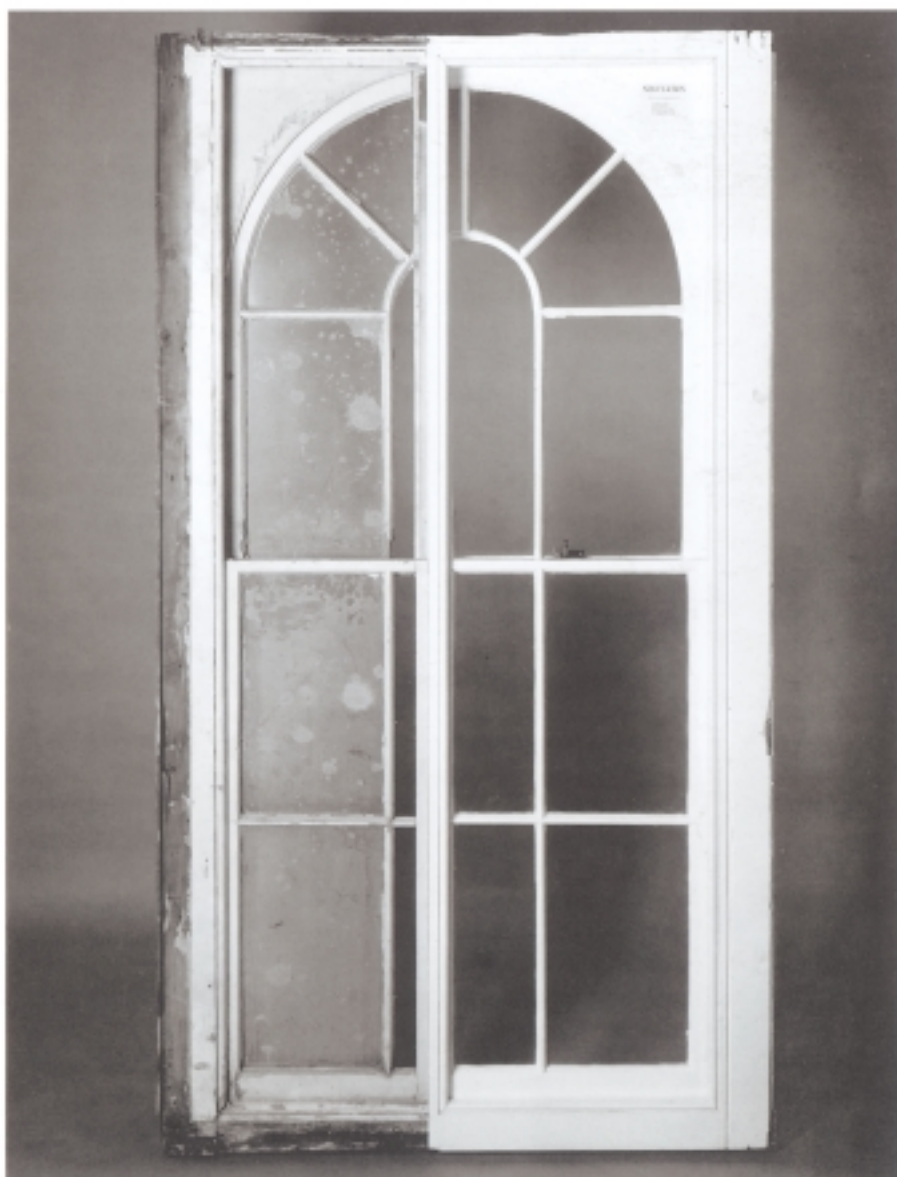
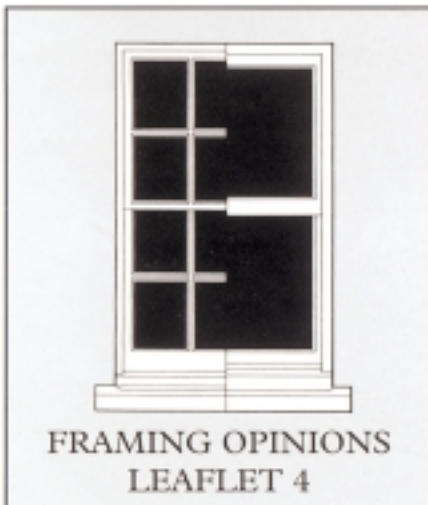
*A late Georgian sash window of c1800, partly restored, from Greenwich, London*
